# CASE STUDY

## Custom Can & Packaging Inspection Machine

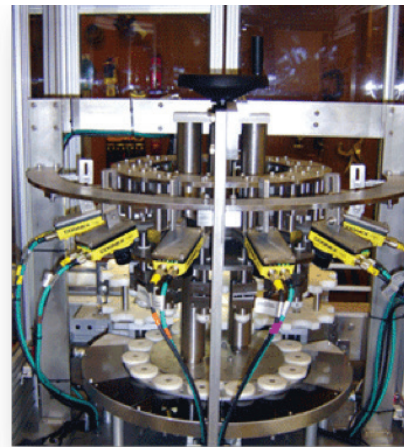
From the star-wheel, cans are transferred to a platen which are timed to rotate a can 360 degrees within a 180 degree turn through one-side of machine. Six overhead cameras scrutinize the can as it is rotated. Cans are checked for dents that might impede the puck rising. A custom lighting set-up is required to complete the inspection.

Defining the type of dent that might impede the puck is a difficult process for a machine vision integrator. A shallow but large dent or a small but sharp dent may stop the puck. These differences had to be combined into one fail process. The inspection machine has an 80% successful identification rate, which exceeded customer specifications. An 8th camera was added later to inspect for crushed or misshapen can lips.
